Flood Monitoring Forms and Data Sheets

The Plan of Action for the monitoring of the bridges on the flood watch list includes the determination of when the bridges should be monitored together with procedures to monitor them.

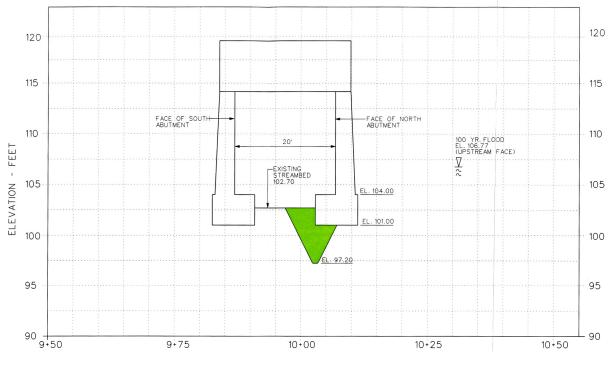
Calculated Scour Depths at 100-year Flood

Route: 4 (Kindermack Road) **Community:** Hackensack City, River Edge Boro

Superstructure Type: Concrete encased, rolled steel multi-stringer Substructure Type: Reinforced concrete full height Abutment Foundation Type: Spread footing Pier Foundation Type: None

History of Scour Problems: Reports of undermined footings History of Debris: Reports of no or very minor debris Streambed Material: Silt or fine sand Substructure Redundancy: Yes
