**NEW JERSEY DEPARTMENT OF TRANSPORTATION
MEMORANDUM**

SUBJECT: Clarifications to Vertical Underclearance Posting Requirements

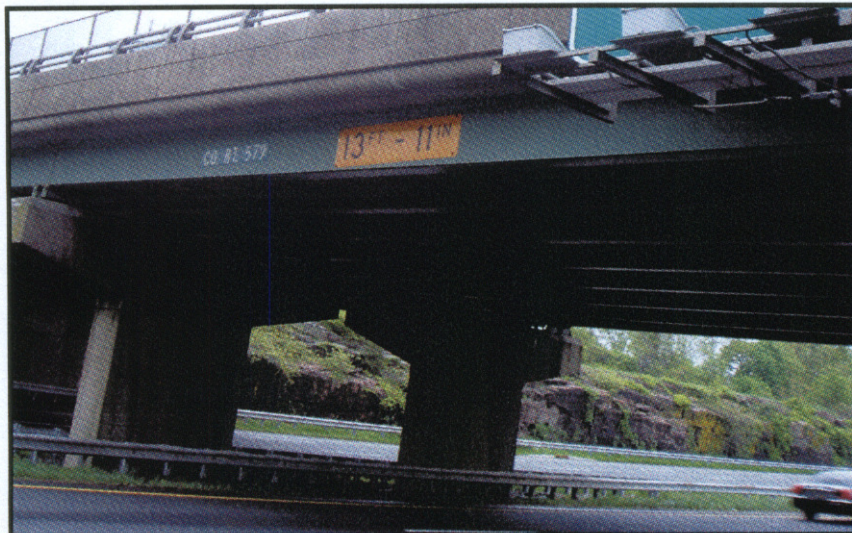
Case A. Single posting sign indicating the overall minimum vertical clearance for all travel lanes

If the difference in minimum clearance measurements does not exceed three inches between *any* two (or more) travel lanes, only one posting sign is necessary to cover all travel lanes (Case A). If the difference in minimum clearances exceeds three inches, however, each travel lane must be posted separately (Case B).

When an inspector identifies a structure that should be posted as in Case B but is actually posted as in Case A, a Priority 1 Memorandum should be issued to the Bureau of Traffic Engineering and Investigations to correct the posting. Conversely, if an inspector identifies a structure that should be posted as in Case A but is actually posted as in Case B, no Priority Memorandum needs to be written.

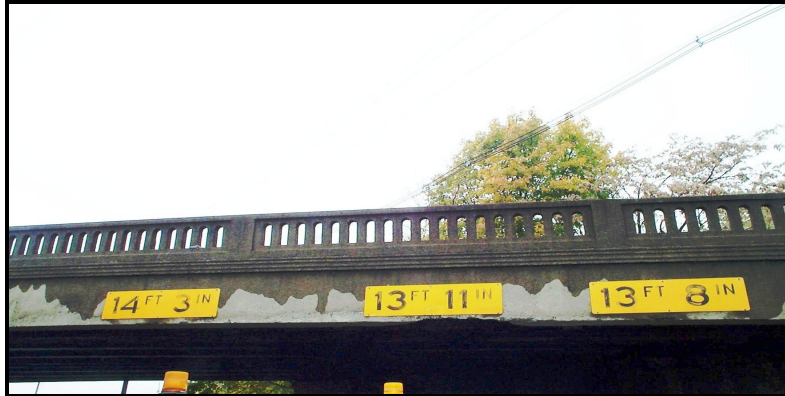
Case B. Each travel lane has its own posting sign indicating the minimum vertical clearance for that particular lane

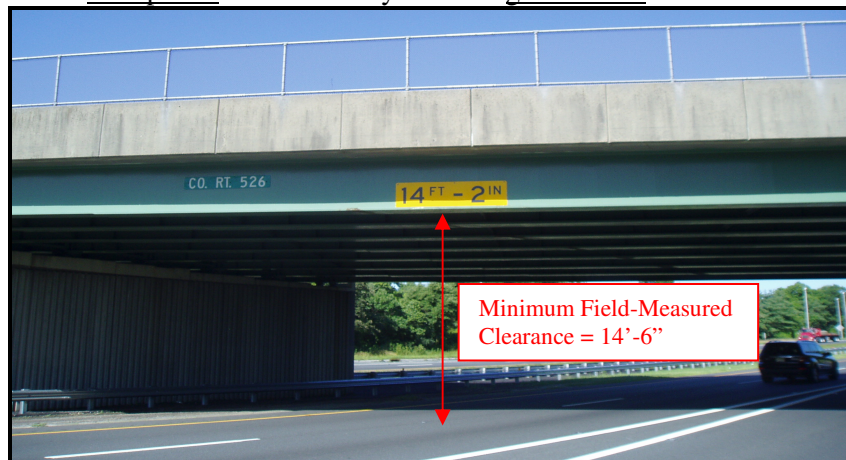
Examples: A. Acceptable because safety factor is greater than 3 inches.

All structures that are posted for inadequate vertical underclearance must have a factor of safety of at least 3 inches less than the minimum field-measured clearance. For instance, if the minimum vertical underclearance of a structure is field-measured as 14'-3", the posted clearance sign should never exceed 14'-0". This factor of safety is necessary to account for factors such as snowpack reducing vertical clearances or suspension oscillations temporarily increasing vehicle heights.

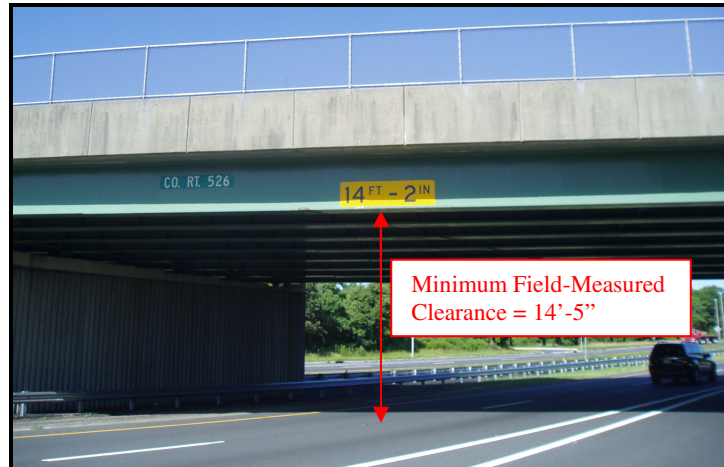
B. Acceptable because safety factor equals 3 inches

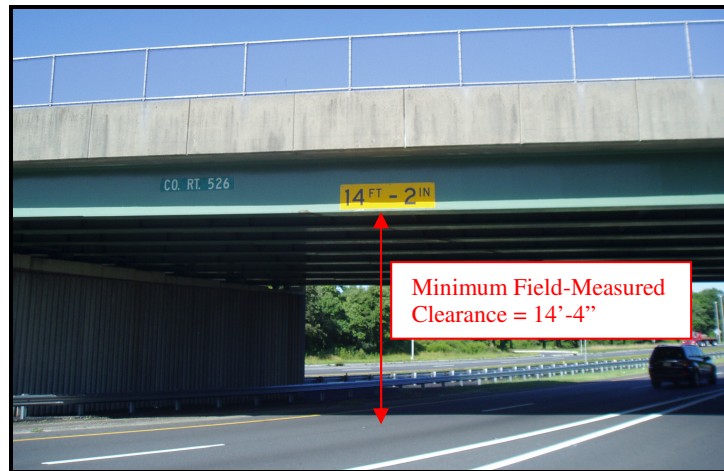
C. Unacceptable because safety factor is less than 3 inches (inspector must write PR-1 Memo to correct).

If an inspection team determines that a safety factor of at least 3 inches is not implemented on a posted structure, the team must issue a Priority I Memorandum to have the structure reposted.
